Sacramento River Flood Control System Evaluation
Initial Appraisal Report - Upper Sacramento Area

**BASIS OF DESIGN
GEOTECHNICAL EVALUATION OF LEVEES
FOR
SACRAMENTO RIVER FLOOD CONTROL SYSTEM EVALUATION
UPPER SACRAMENTO AREA - PHASE V**

February 1993

**PREPARED BY
SOIL DESIGN SECTION, GEOTECHNICAL BRANCH
U.S. ARMY ENGINEER DISTRICT, SACRAMENTO
CORPS OF ENGINEERS**

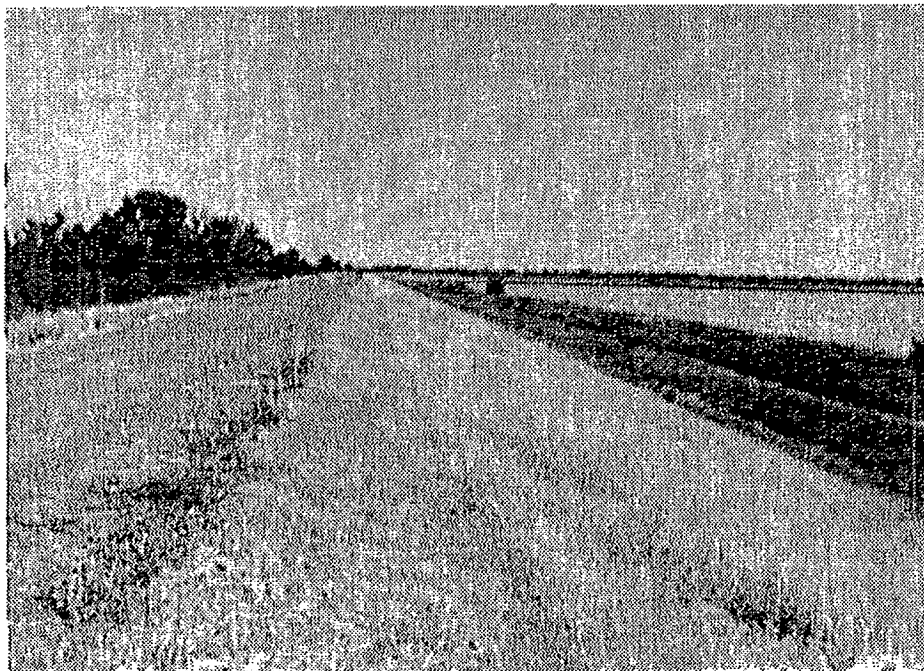
The levee and foundation profiles are shown on Plate 37. The levee cross sections are shown on Plate 38. The Sutter Bypass levee is typically about 24 feet in height with a 15- to 20-foot crown width, a IV on 2H slope on the landside, and a IV on 3H slope on the waterside (Photos 26 and 27). The waterside slope of the levee is rock revetted. There is a 50-foot-wide berm between landside toe and an irrigation ditch. The west Sutter Bypass levee was raised by the Sacramento District in 1941. Based on available borings, the foundation consists of a 4- to 5-foot clay layer on top of a 2- to 5-foot layer of hardpan. Beneath the hardpan is alluvial clay with silt and sand layers. Pervious sand and silt layers generally occur within 5 to 10 feet of the surface.

Photo 26: Site 8 - Looking downstream along lands ide slope. An irrigation ditch running parallel to the lands ide toe. (May 21, 1992)

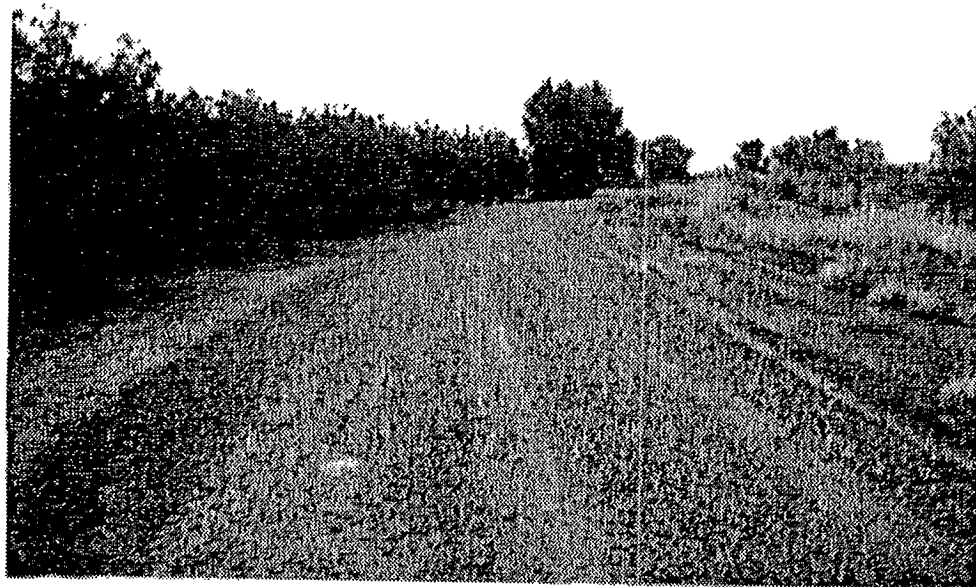
A typical levee cross section is shown on Plate 26. The Elder Creek levees typically range in height between 3 to 7 feet. The levee crown width is typically 12 feet. The landside and waterside slopes are variable and range from approximately 1V on 2H to 3H (Photos 34 and 35). The foundation soils from the surface to a depth of about 8 feet are relatively impervious, consisting predominantly of sandy clay and sandy silt. Below 8 feet are discontinuous layers of pervious materials such as silty sand and sandy gravel.

During the high water of February 1958, the locally constructed levee experienced erosion and seven levee breaks varying from 30 to 250 feet in length. These failures were caused by overtopping and erosion. The Elder Creek levees were reconstructed by the Sacramento District in 1959. It was reported that during the high water of 1986, levee overtopping occurred at the Southern Pacific Railroad Bridge. The levee overtopped at the south bank due to debris at the bridge. The other problem area is located at the lower end of the Elder Creek levees where overtopping can occur during high stages. Depending upon stages in the river versus stages in the creek, river water can overtop the levees. Also, sediment tends to build up in this reach of Elder Creek when backwater from the river slows velocities in the creek.

During the field inspection the Elder Creek levee appeared to be stable, in good condition, and well maintained with no sign of erosion or settlement. The problems reported above are considered a local maintenance responsibility. It is concluded that no reconstruction is needed for the Elder Creek levees.

Photo 34: Elder Creek. Typical South bank levee. (Oct 26, 1992)
